CORROCOAT

Case study: Biofoul for inlet screens

Huge savings with over 4 years' service and virtually no marine growth.

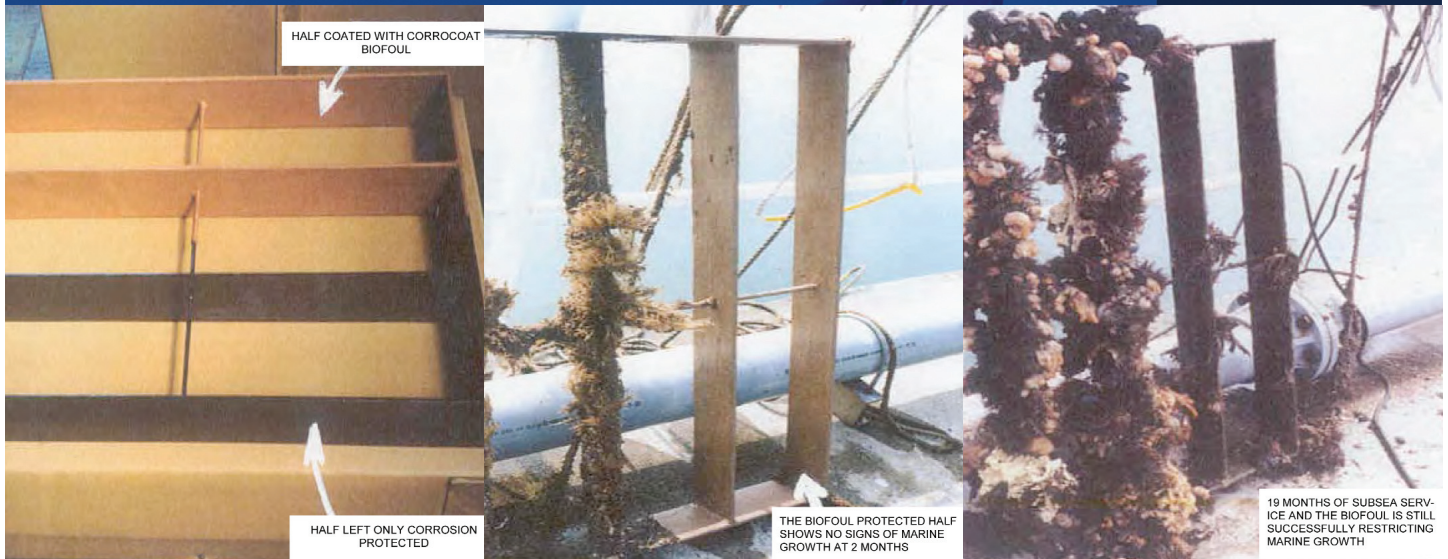
Photographs

Left: Clean sample coated totally with Polyglass anti-corrosion coating, and half recoated with a veil of Biofoul. When first applied, Biofoul is copper/gold in colour. The colour changes with age to the pleasantly green appearance of oxidised copper.

Middle: The sample after just 2 months sub-sea service.

Right: The same sample after 19 months sub-sea service.
