Case study: VEF for venturi scrubbers

Extended life for venturi scrubbers.

Steelmaking industry, Australia.

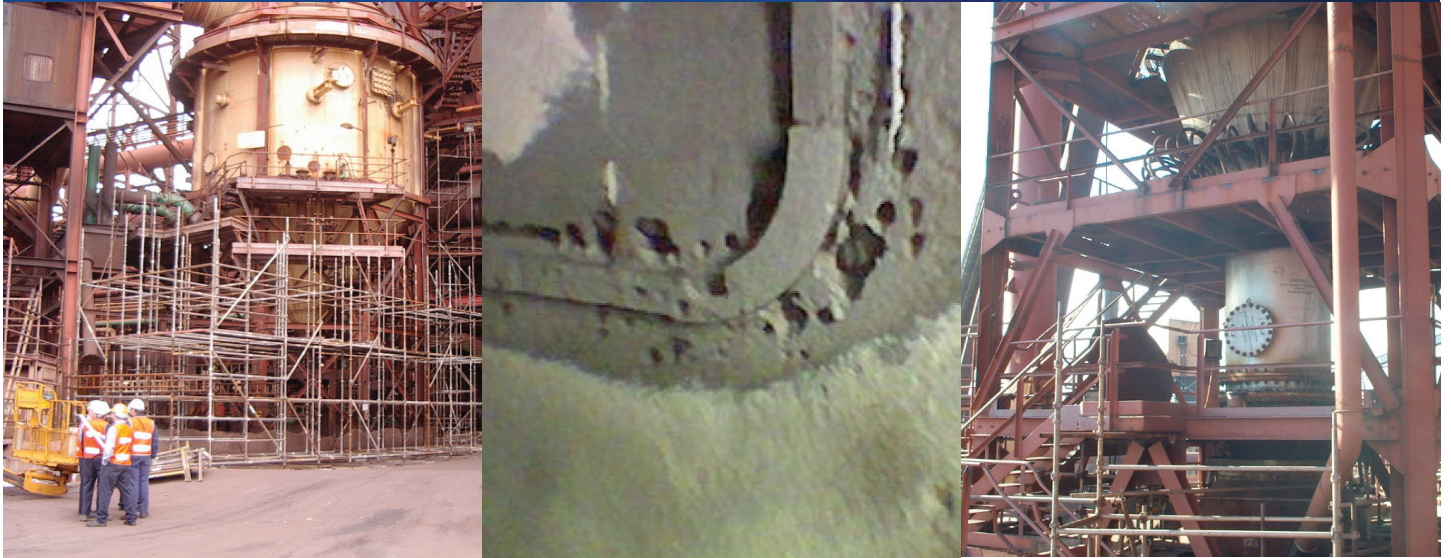
Photographs

Left: [The scrubber prior to blasting and coating.](#)

Middle: [Visible perforations seen after initial blasting.](#)

Right: [A view of the externals of the venturi scrubber.](#)

- Grit blast internally to SA 3.
- Wash to reduce Metallic Salts.
- Pitfill with Corroglass 602 & repaired with 600g quadriaxial glass fibre laminating fabric.
- Apply Polyglass VE/VEF to a minimum dft of 1.5mm.
- 100% Spark tested and thickness checked.

Prior to Corrocoat Engineering Victoria's involvement in 1995, this critical pressure vessel required patch weld repairs every six months, necessitating regular scrubber shutdown periods to combat corrosion which was causing through-plate perforation and leaking.
