Case study: Corroglass 600 for water boxes

Repair and protection for air cooler water boxes.

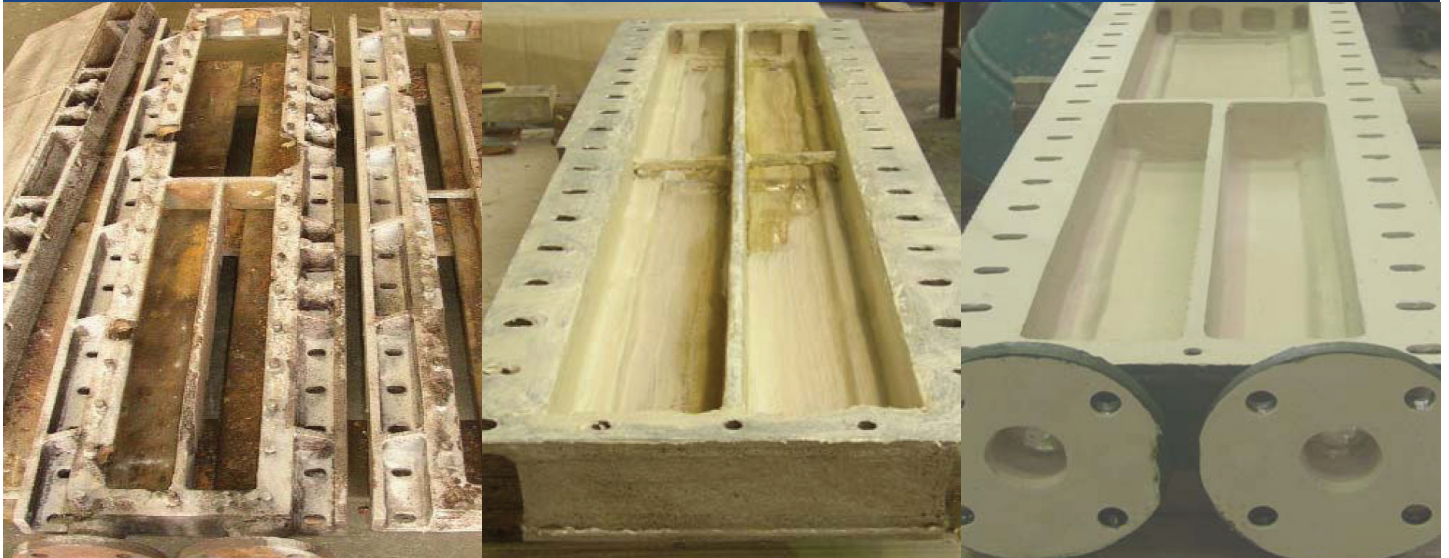
Due to severe sea-water corrosion leading to leakage, repair and future corrosion protection was essential. Also some mechanical modifications were carried out as specified by client.

Motor oil cooling waterbox.

- Internal grit blast to ISO 8501-1 SA 2½.
- External grit blast to ISO 8501-1 SA 2.
- Hand application using specialised techniques to rebuild seven damaged water boxes to provide effective, anti-corrosion protection.

- Application internally of Corroglass 600 series to achieve a minimum dft of 1.5 mm. Coated across the flange faces and fully spark tested at 19kv and thickness checked.
- Hand application of Plasmet ZF 150µm, followed by a top coat of enamel cosmetic top coat in customer's house colours.
