Case study: Corrocoat protects spillway gates

Corrosion protection for australian spillway gates.

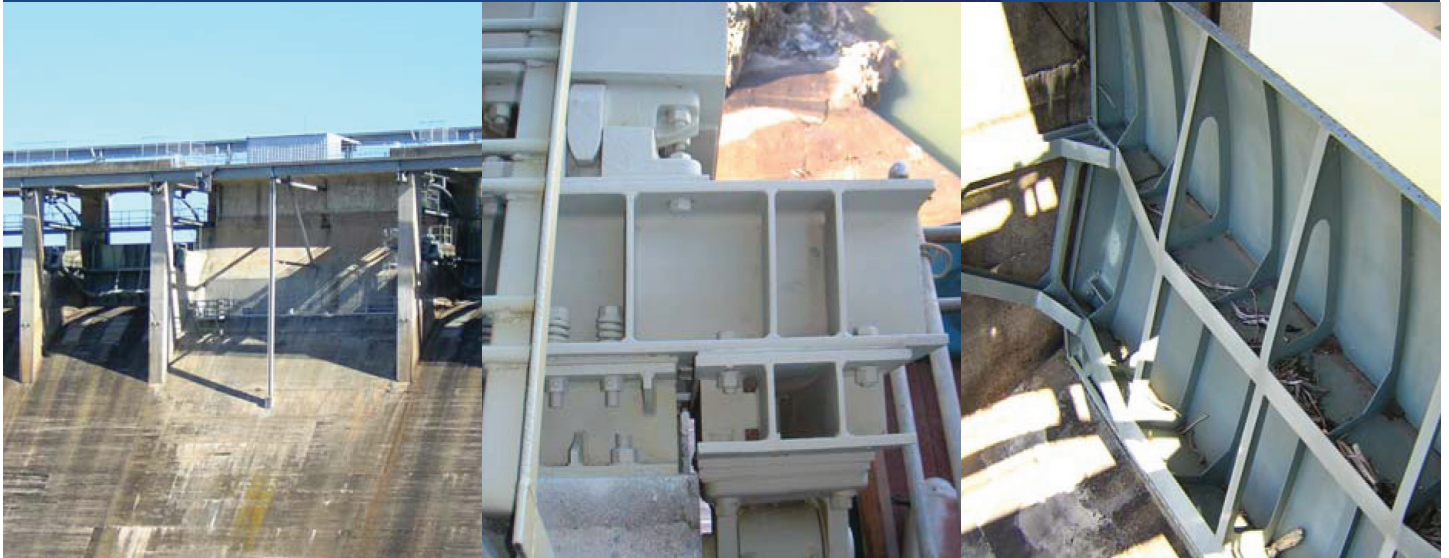
Left: [The spillway gates at Glenmaggie. Access to the gates was the first hurdle for Corrocoat.](#)

- Access to the gates is difficult and expensive being 80 metres above the river bed, so long term corrosion protection is highly desirable for this asset with a required life of 200 years.
