# Case study: VEF & ARMAGEL for water filters

# Quadruple life expectancy for coarse water strainers.

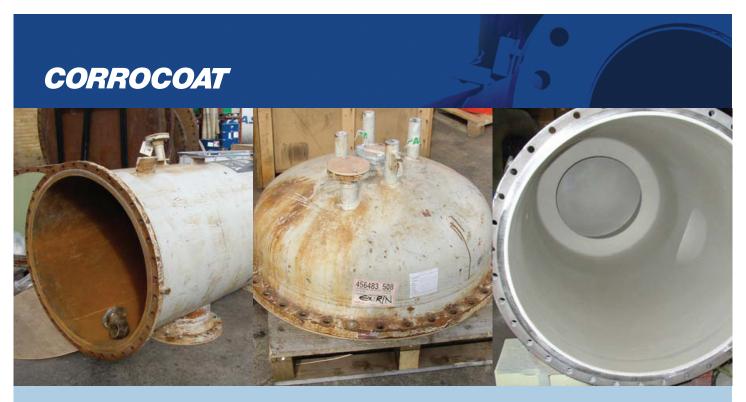
Left: Filter vessel on arrival at the Leeds works. Middle: Vessel end externals and bolt holes.

Right: Completed vessel internals.

Machine out the internals of the vessel and fit a top and bottom impact ring in stainless steel. Coat the remaining internals for abrasion and corrosion resistance. Paint externals to house colours.

- Grit blast internally to SA 21/2.
- Apply VEF to minimum dft of 1mm.
- Apply Armagel to total dft of 1.5mm, into flange rebates and finish flat.
- Thickness check and spark test at 19kV.

Corrocoat offered a solution of inserting stainless steel impact rings at the top and bottom of the vessel to take the majority of the mechanical damage and coat the rest of the internals with a corrosion and abrasion-resistant lining. The initial life expectancy of the strainers was 2-3 years before they came out of service for maintenance. With the Corrocoat Corrosion Engineering Retrofit package, the strainers are lasting in excess of 12 years before any maintenance is required.
