## Case study: Polyglass for bridges

### Winter maintenance for railway bridge.

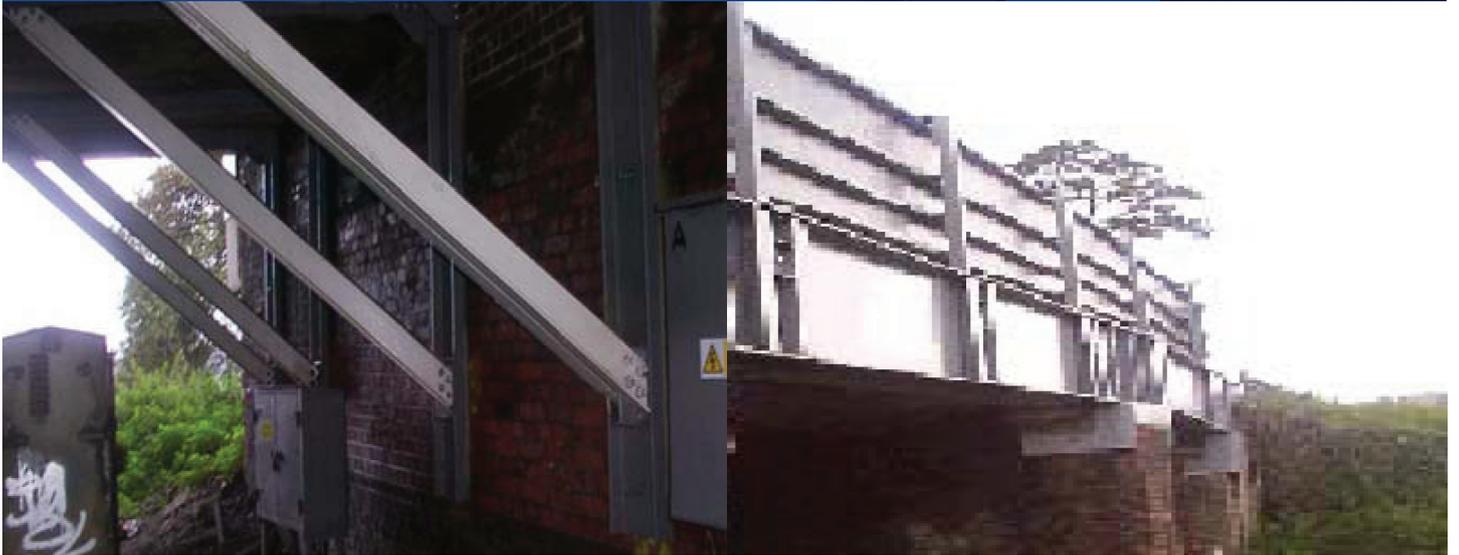
Left: [Structural members erected and coated.](#)

Right: [Successful completion within project time scale.](#)

- Grit blasted to SIS 05 5900, SA 2½ (Relate to Corrocoat data sheet SP1, 6/30).
- Zipcoat applied by airless spray, minimum film thickness 850µm (Refer to Corrocoat data sheets 6/20).
